Manhole Inspection Summary

Manhole # S43SS_026MH

Location Address: **1701 MONTPELIER ST**

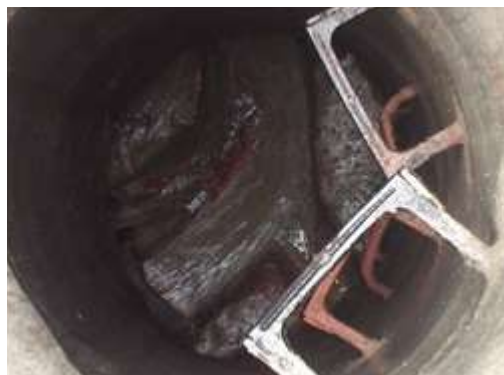
Top View

Infiltration: ☐ None ☒ **Joint** ☐ Cracks ☐ Mortar ☐ Roots ☒ **Wall**

Count: **7** Missing: **0** ☒ **Corroded**

Corroded steps. Adjustment infiltration.

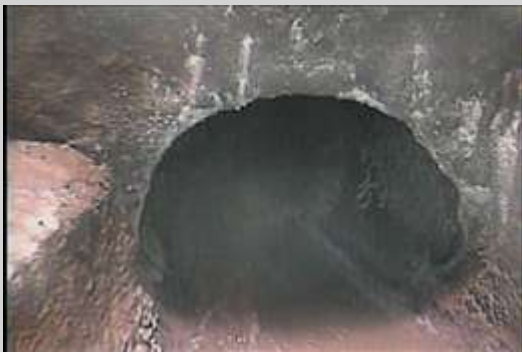
18 in. Circular Gravity Sewer Pipe Out @ 12 O'Clock

Invert Depth: **12.67** (ft.) Flow Characteristics: **Fast**

Infiltration: **None** Pipe Seal Cond: **Unknown**

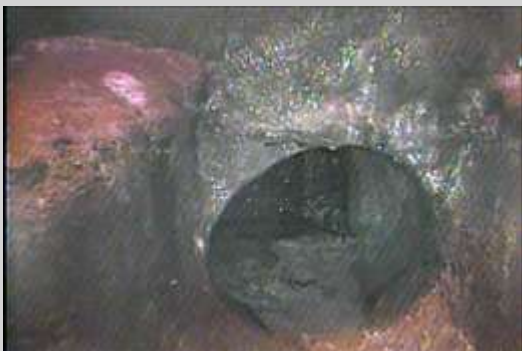
10 in. Circular Gravity Sewer Pipe In @ 5 O'Clock

Invert Depth: **11.93** (ft.) Flow Characteristics: **Slow**

Infiltration: **None** Pipe Seal Cond: **Unknown**

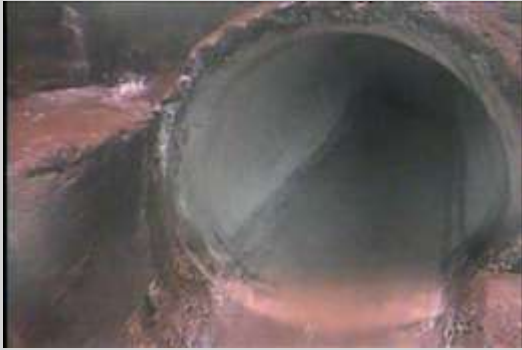
8 in. Circular Gravity Sewer

Invert Depth: **12.08** (ft.) Flow Characteristics: **Fast**

Infiltration: **None**

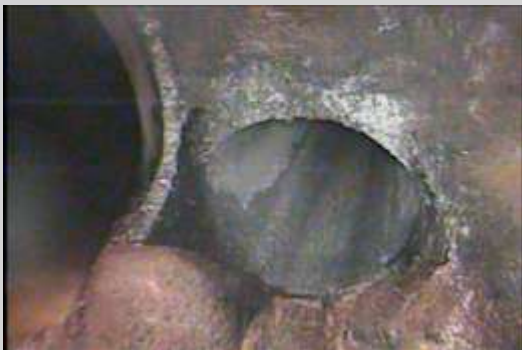
18 in. Circular Gravity Sewer

Infiltration: **Evidence**
